Project Profile

Hudson Hospital Diagnosing the issue.

Project:
Custom Polish and Stain

Location:
Hudson Hospital
Hudson, WI

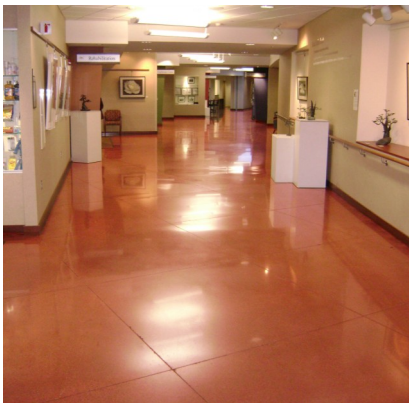
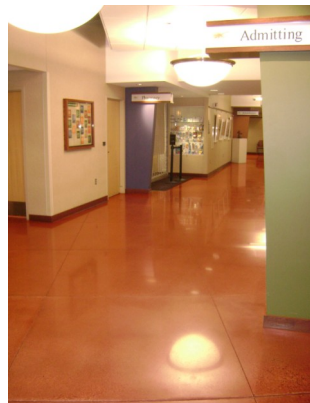
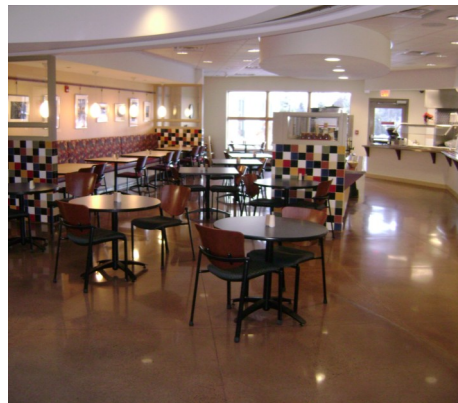
The Hudson Hospital was enduring discoloring and blistering from a colored urethane coated flooring system. This type of flooring was not the right system for the Hudson Hospital because of vapor drive issues. The moisture was pushing up through the floor while the Urethane blocked the natural vaporization and simply not allowing it to breathe and causing deformities.

Problem:
Vapor and moisture caused discoloration and blistering

The best solution was to grind the Urethane and polish the floor. The hospital

liked the color that it had, so we matched the flooring with a colored dye similar to the original Urethane.

Custom polishing the floor now allows the Hudson Hospital flooring to easily breathe which doesn't block in the moisture. It has a great sheen, reflectivity, and color that really enhances the inside aesthetics. The best thing about the floor is that if you walked into that hospital today, it looks exactly as it did when we first finished the project five years ago.

Solution:
Polishing is a breathable flooring option. The Urethane was ground off and the floors were dyed and polished for sheen.

Results:
The floors easily breathe and look as great as they did when the project was first finished.
