Project Profile

YMCA Floor Restoration

Project:
Custom Polishing

Location:
YMCA
2211 Vine Street
Hudson, WI 54016

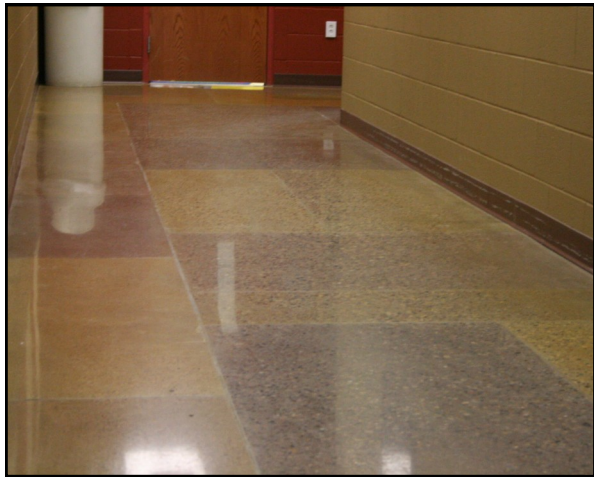
The YMCA carpets were worn-out and had visible stains and water damage which hindered the overall appeal of the building. A custom polished floor deemed the best solution for the YMCA due to its durability and ability to save on maintenance costs.

During the preparation of the floor, we found many challenges once the carpet was removed. There were uneven heights in the flooring due to separate foundation floors and random cracking. To fix this base problem, cracks were routed out and filled with Polymer modified grouts and structural cracks were filled with Epoxy to bond slabs back together.

To enhance the appeal of the flooring, faux joints were cut in and grouted to simulate an ashlar slate pattern in the flooring and individual ashlar squares were custom stained to add dimension. The YMCA now has a durable floor that looks great and it's easier to maintain.

Solution:
Remove carpet-
ing and adhe-
sives. Grind,
stain, and pol-
ish floors.

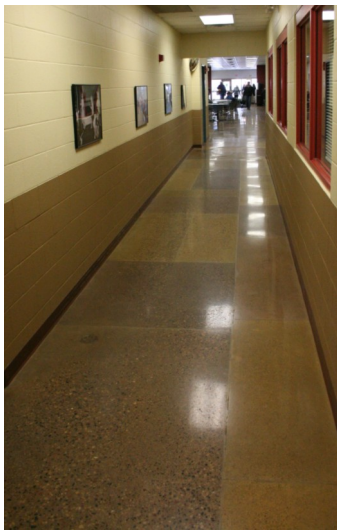
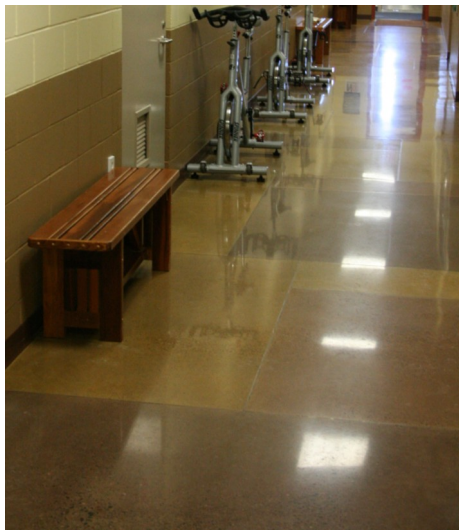
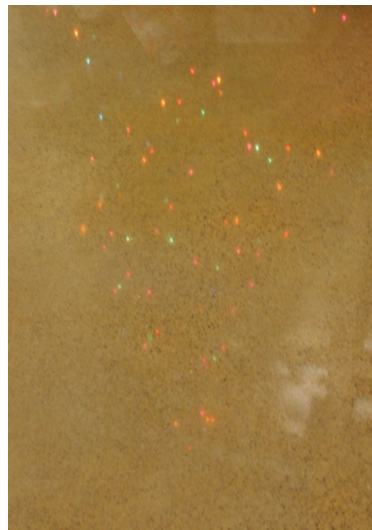
Problem:
Old, worn-out
carpet with
stains and water
damage
